11,13 ESSEX STREET

BOSTON, MASSACHUSETTS

DOCUMENTED DECEMBER, 1972

11 - 13 ESSEX STREET BOSTON, MASSACHUSETTS
(1871 -)

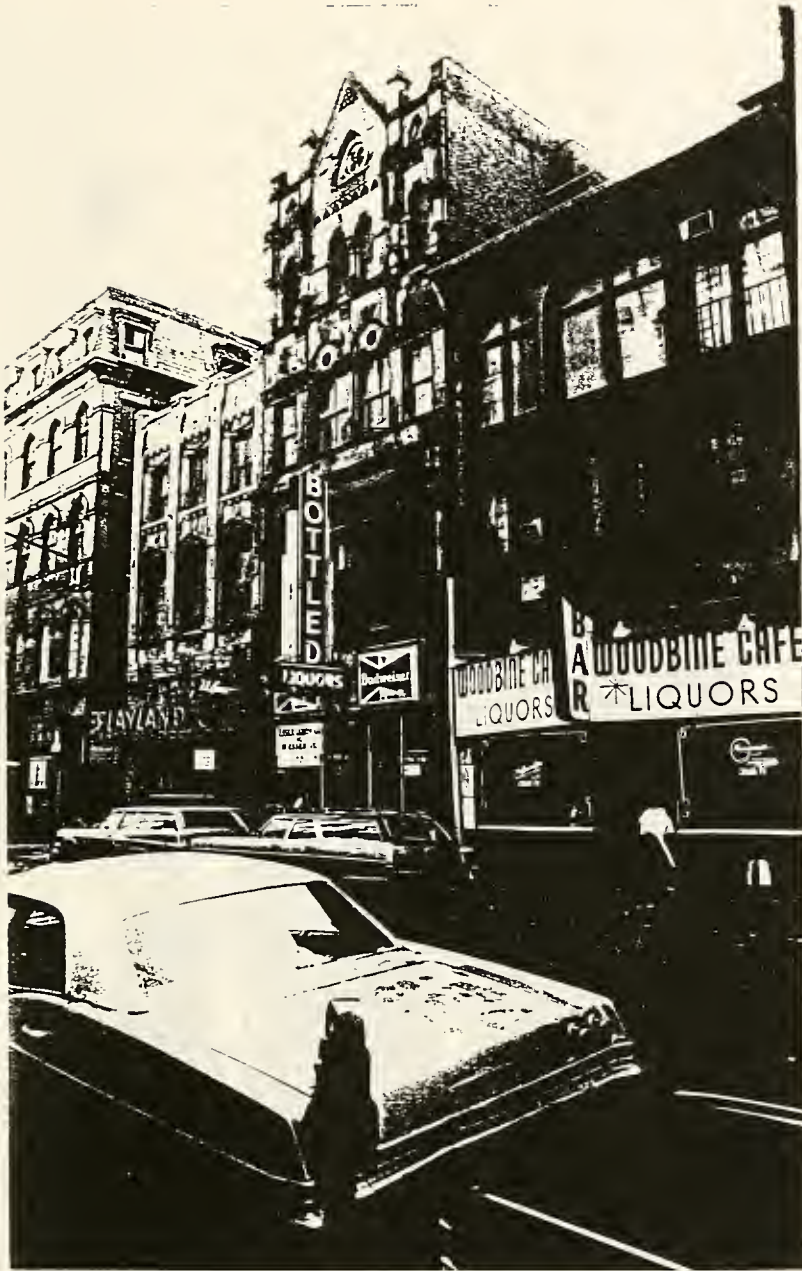
17 essex street

After the turn of the century, number 17 Essex Street became increasingly converted to purely commercial uses, as was typical of many such buildings. The earliest known photograph of the building (c. 1890), reproduced below, shows that the top floor continued to be used as a dwelling, but that the third floor had apparently been turned into storage space. (The building is not open to inspection, nor are original documents available pertaining to it which would provide more specific information concerning the building's tenants.⁴ We do know that it was occupied by the Stern Sewing Machine Depot, second floor tenants around 1890 as the photograph indicates; by an unnamed restaurant from 1915 to 1928; and by the Essex Liquor Store from 1933 to the present. The latter establishment apparently uses the entire building for retail sales space and for storage.

The building itself shows some signs of wear from continuous use, but it evidently has undergone no radical alterations. Comparison of our 1890 photograph with the 1968 one, reproduced below, shows that the facade has been altered by the addition of two windows in the third floor. (No record exists of this alteration.) From the pattern of the stonework and the carvings on the facade in the early photograph, however, we assume that this is the original design of the building in every other respect.
